## **ENVIRONMENTAL DETERIORATION AND CONSERVATION OF MONUMENTAL BASALT, EGYPT**

**Badawy Ismail**

Conservation Dept., Faculty of Art , South Valley Univ., Qena

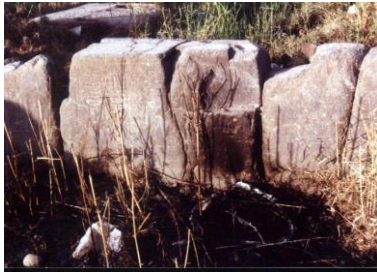
**Fig. (1):** Basaltic blocks highly cracked due to weathering & plant vegetation, Memphite

the mineral disintegration. The colour of the basalt is changed and the surface layer was cracked and fell into Flakes (Pl.1, Fig.1). In addition fissuring, cracking and porosity of weathered basalt have been increased. Weathering of basalt produces an amount of insoluble material as a result of chemical processes which change ferrous iron to ferric iron of the mineral constituents. This alteration produces cracks and points of weakness which cause disintegration of basalt and its discoloration (Pl. 1, Fig. 2).

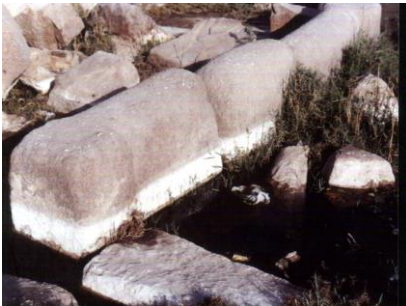
**Fig. (3):** Field view showing parts of basaltic blocks immersed in domestic water. Salt efflorescence can be noted

The change in relative humidity plays an active role in Basalt decomposition. The durability analyses show the effect of groundwater which carry different insoluble salts that are giving rise to salinization of Basalt (Pl.1, Fig. 3). There is a capillary migration of the soluble ions from saline soils in this site. Groundwater assists in the weathering of basaltic minerals leading to the formation of clay minerals. Microcracks in the stone are saturated with water, weakening its structure by enlarging these imperfections. These cracks allow the circulation of groundwater and constitute an inherent source of weakness and a serious defect.

solutions with the same major cation can cause salt precipitation (Pl.1, Fig. 3). Hydration and dehydration of the crystallized salts also play a role in the stone decomposition as the volume of the salts increases for sodium sulphate crystals. Another possible category of salt weathering processes involves the differential thermal expansion of the salts. Also, salts entrapped in stone pores may have greater expansion coefficients than the stone minerals. (Pl.1, Fig. 5) shows that the migration of the salt solution to the surface of the stone is faster than the rate of drying. The liquid passes out the surface and the crystals of the soluble salts deposit there on the top of the external surface resulting in a visible efflorescence form (Pl.1, Fig.3). Thus the action of the chlorid salts that are highly hygroscopic being the first salts which dissolve grains with water condensation, make them pulverize the stone by granular disintegration.

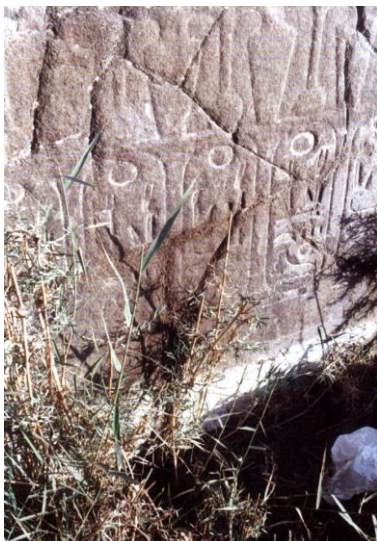
**Fig. (5):** Basaltic block showing white salt efflorescence at its base & coarse single cracks, Memphite.

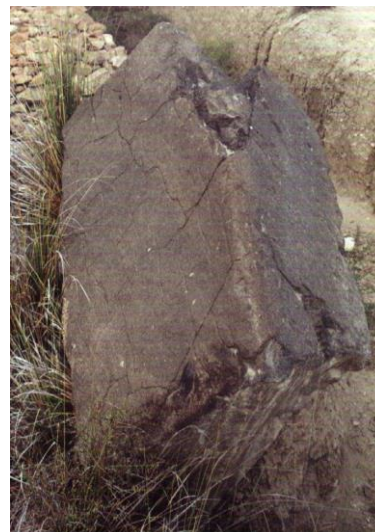
**Fig. (6):** Parts of basalt show cracking & severe weathering. Dense plant vegetation indicates new surface water at tell Basta.

So, the deteriorations of basaltic monuments are continued by new cracks in the stones and exfoliations from the surface. The formation of tensional and radical cracks by weathering are widened by exfoliation (Pl.1, Fig. 6) Moreover, Deterioration of basalts seems to be originated through microveins in their structure and fragments from the outer parts of monumental basalt which fall down due to its decohesion (Caner., 1985).

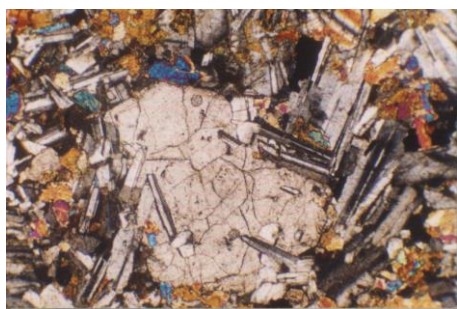
**Fig. (1):** The stone is composed mainly of plagioclase, clinopyroxene as essential minerals. Iron oxide occur as accessory minerals.

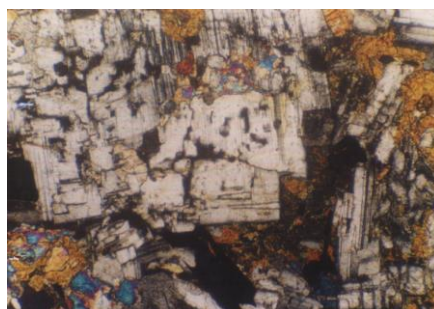
**Fig. (2):** Plagioclase feldspar crystal with “patchy zoning” which described as corrected core of plagioclase crystal and the outer ones are more sodic in composition. Inclusion of this sodic phase appears in the corroded core.

Plagioclase is partially weathered and replaced by irregularly shaped and distributed patches of secondary clay products along its cleavage planes and fractures, whereas the external more sodic part of the zoned crystal is much less affected by weathering (Pl.2, Fig.2). plagioclase crystal is characterized also by "patchy zoning", and corroded core of (Pl.2, Fig. 3) while the outer zones are more sodic in composition. Inclusions of this sodic phase appear in the corroded core.

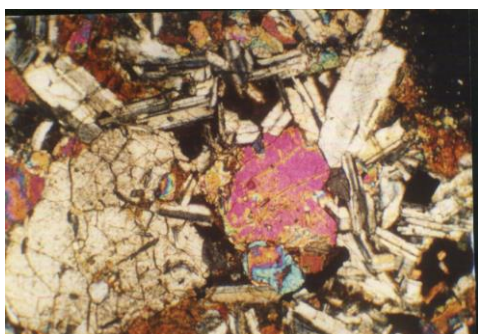
**Fig. (3) :**Corroded, fractured and twinned plagioclase feldspar crystals. These crystals are prismatic with “T-shape” intergrowth. The large plagioclase crystal is the middle & vien showed as affected by deep cracking

The large plagioclase crystals are shown to be affected by deep cracking (Pl.1 Fig.2). The weathering starts in the plagioclase crystals in the peripheral parts of the crystals. The clay minerals are formed as a secondary clay products after plagioclase along the network of intergranular micropores. The weathering of twinned crystals of plagioclase have begun along intramineral cracks (Pl.2 Fig.3) in which highly altered and corroded phenocrysts of plagioclase with diagonal fracturing along the crystals and several fissures are more recently formed. Plagioclase is progressively replaced along numerous fissures. The transformation of the plagioclase into secondary clay minerals which is concentrated on the rim of the core with an appreciable increase in volume has promoted the opening of many intermineral fissures and fractures (Pl.2, Fig.3). The intermineral

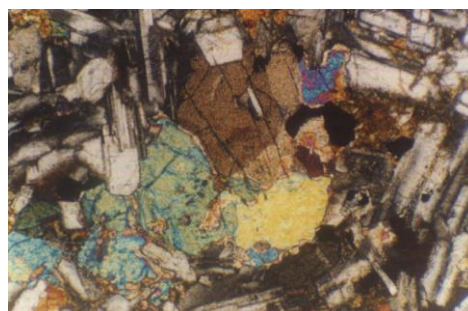
**Fig. (4):** highly affected and corroded phenocrysts of plagioclase and pyroxene with diagonal fracturing along the crystals and the alteration products concentrated on the rim than the core also alteration of pyroxene and olivine crystals was clearly observed

Corroded, fractured and twinned plagioclase feldspar crystals are prismatic with "T-shaped" intergrowth (Pl.2., Fig. 4). The internal border of the rim is highly irregular and the products of weathering irregularly penetrate the residual core along digitating and tranching fissures.

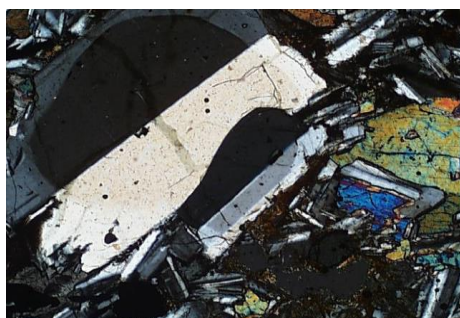
**Fig. (5):** Polysynthetic lamellar twinning of plagioclase phenocrysts in basalt sample. Cracks are also observed.

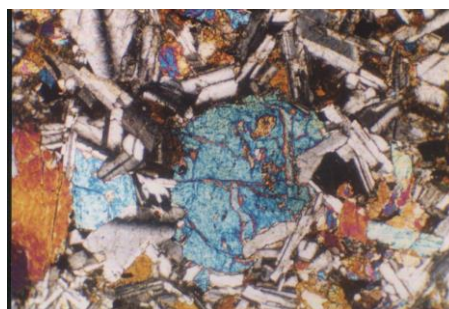
**Fig. (6):** Phenocrysts of olivine highly altered to irregular brownish products. With extensive network of intramineral fractures.

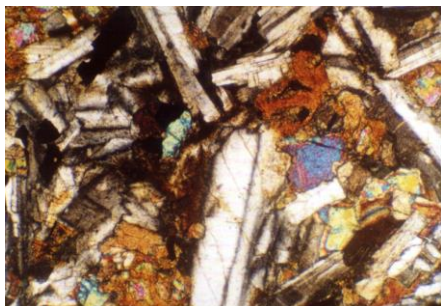
**Fig. (1):** New formed crystal of carbonaceous material with well formed two sets of cleavage as alteration products of plagioclase

Olivine crystals exhibit an irregular with sinuous outline colorless in polarized light changed to bright green in crossed nicols. There is an extensive network of intramineral fractures. (Pl.3, Fig.1). The crystals of olivine have been partially transformed to iddingsite (Pl.2, Fig.1). These fractures are the pathways along with the alteration begins in the minerals. Many intramineral cracks are still visible, and they appear as dark curved thin lineaments coated with iron oxides (staining). The more weathered crystal of plagioclase is altered to smectitic clay which is crossed by numerous irregular fractures (Pl.3, Fig. 2). A slight degradation of clay minerals particles includes the formation of a thin brownish rim of iron oxyhydroxides around each of these fragments.

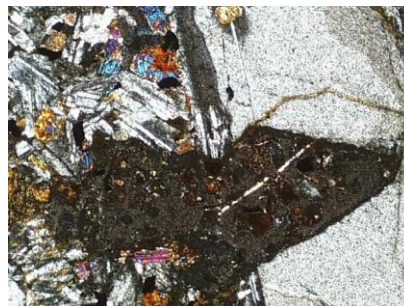
**Fig. (2):** Fractures and fissures in the internal Structure and the formation of clay minerals as secondary alteration.

Vesicular structure filled with neoformed crystals of calcite is shown in (Pl.3, Fig. 2) as alteration products.

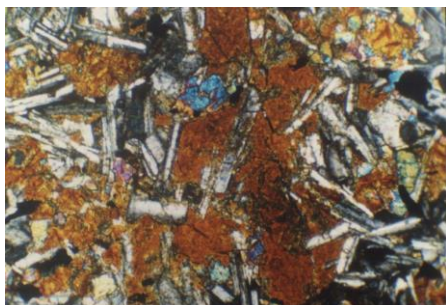
**Fig. (3):** Iddingsite alteration minerals due to weathering process.

Olivine has been completely replaced by bright red iddingsite. These secondary products exhibit an irregular banded pattern (Pl.3, Fig. 3). Iddingsite still contains small remnants of partially and also penetrates the olivine crystal as to a peripheral and an irregular linear pattern. The large residues of Olivine cores altered to brownish iddingsite. Open transmineral fractures cross grains of Olivine have been replaced by iddingsite. The reddish brown iddingsite is highly birefringent.

Also olivine crystals have been partially altered to serpentine and the large residues of olivine cores have been altered to brownish Iddingsite. (Pl.3, Fig.3) Deposits of secondary magnetite associated with the formation of serpentine. Serpentine is present as the alteration products after olivine. It is present in the form of fibrous yellowish crystals usually along the borders and cracks of the olivine grains. Pyroxenes occur in the form of anhedral to subhedral crystals with two sets of cleavage. Pyroxenes are characterized by corroded outlines defined by fine grained iron oxides.

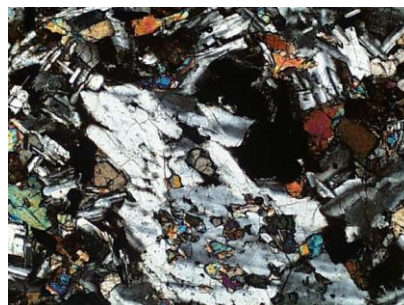
**Fig. (4):** Fragmentation of pyroxene, and olivine minerals.

clay minerals in the fracture within or between the neighboring grains of pyroxenes and the opening of many interlayer pores in clay material (Pl. 3, Fig. 4).

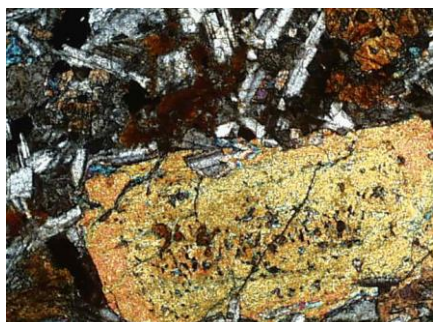
**Fig. (5):** Prohyritic texture, large phenocrysts of pyroxene embedded in a fine groundmass of plagioclase, pyroxene and olivine partially altered with rugged out lines.

Pyroxene crystals are observed as fractured and crossed by many intramineral cracks. (Pl. 3,

Fig.5) shows a phenocrysts of pyroxene embedded in a fine groundmass of plagioclase and olivine. Clinopyroxene is pitted, and cracked altered with rugged outlines. The orientation of some cracks is strongly related to the nearly orthogonal cleavages of the mineral. The intermineral pores are completely surrounded pyroxene phenocrysts and separate them from the weathered basaltic matrix. The network of fissures is irregularly distributed and interconnected. These fissures and pores have been partially infilled with iron rich material derived from the surrounding weathered matrix and under the chemical weathering, the network of cleavages will provide the preferential pathway for the replacement of the crystals by secondary iron oxides and hydroxide chlorite which are formed as a result of the alteration of pyroxenes.

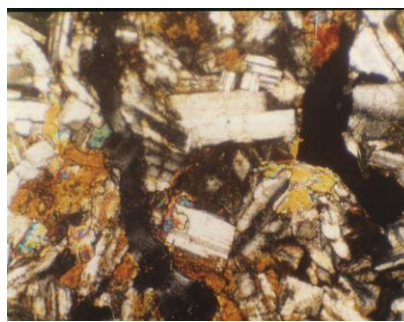
**Fig. (6):** Vesicular structure of basalt filled with minerals (such as iron oxides, salts).

The wide transmineral fractures that cut the stone are infilled with a smectitic clay. The infillings seem to be formed gradually with the opening of the fractures. A part of the colorless pyroxene mineral has been transformed by randomly oriented and distributed microcrystals of green chlorite. Also the irregular grains of clinopyroxene have been replaced by reddish brown oxyhydroxides of iron (Pl.3, Fig. 6). Crystals of orthopyroxene surrounded

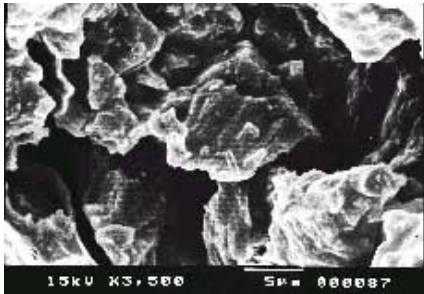
Fig. (1): SEM reveal a heavy deterioration of stone and increasing of porosity

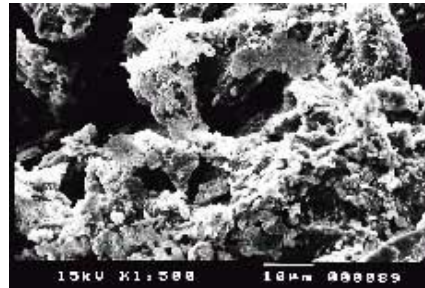
Fig. (2): SEM shows the formation of residual pores developed between the newly formed secondary products and residual fragments.

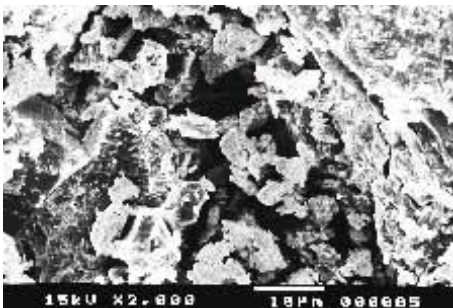
Fig. (3): SEM micrograph shows a network of channels and pores created in the weathered stones.

more fracturing will have access and through flow of weathering by groundwater. Also, there is an increase in the proportion of pores, fissures and channels.(Pl.4, Fig.3) SEM micrographs show that the phenocrystals minerals are fractured and the resulting fragments are separated by open transverse fractures which increase the weatherability of the minerals and consequently the fragmentation of the minerals (Pl.4, Fig.4). The transmineral porosity created by the recent fracturing of the weathering stone under the

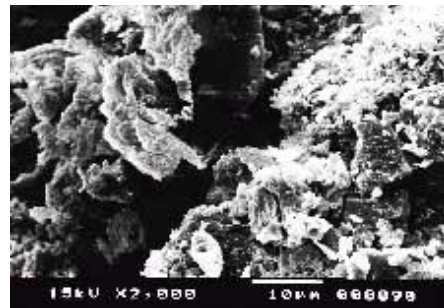
Fig. (4): SEM micrograph shows that the minerals are fractured and the resulting fragments are separated by open transverse fractures.

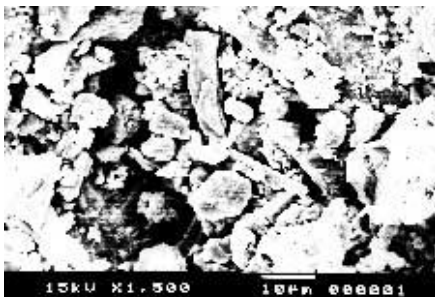
Fig. (5) :SEM shows the alteration and disintegration of minerals

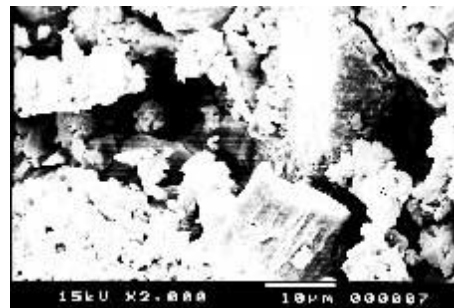
Fig. (6): SEM shows the fragmentation of the minerals and the recent fracturing of stone and the influence of biological erosion

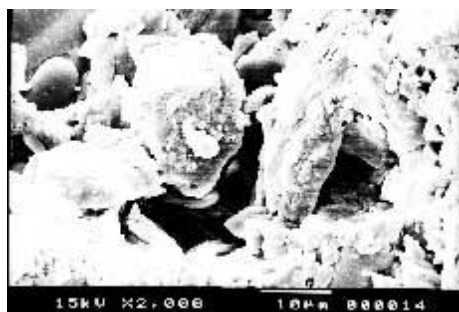
**Fig. (1) :**SEM shows the dislocation and the separation of the grains and the formation of residual pores.

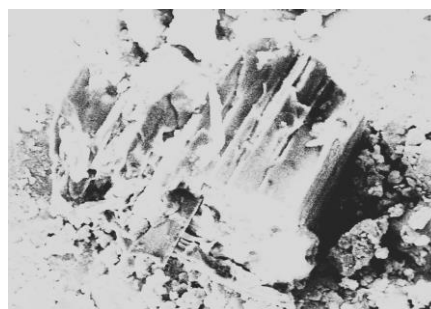
**Fig. (2):** SEM shows microcracks with Basalt texture, pitting crystal, can be noted.

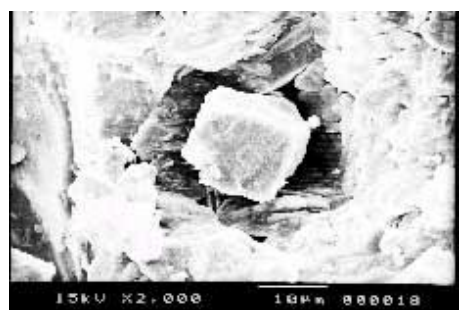
**Fig. (3) :** SEM shows salt crystals form whiskers filling secondary micropores and coats its texture

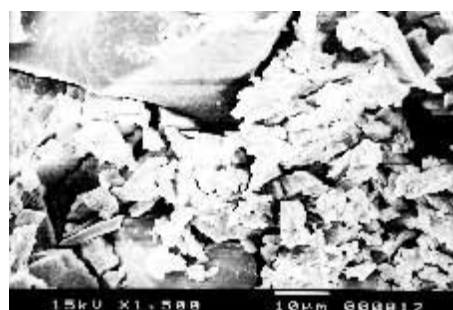
**Fig. (4):** SEM shows that most mineral grains are loosened from each other

fractures cut the pre-existing volumes. It is also detected by examining the studied samples that intramineral porosity may also appear and develop by the degradation of the first –formed unstable alteroplasms. (Pl.5, Fig.4). The dissolution and leaching of several constituents lead to the formations of irregular alveolar pores which may be randomly distributed. The macroporosity is restricted to the fissures, fractures and channels of higher order which cross the alterites and the empty pores existing between the microparticles of secondary products. Also, it can be enhanced as a natural impregnation of coloured materials. Detailed examination on the distribution of this pore space show that it is interparticular and generally uniform and occupy all the available space resulting from the disappearance of the primary minerals. SEM micrographs also shows the pigmentation of the crevice and interspaces between the grain boundaries of the mineral constituents. Pigmented minerals penetrate also into cracks and cleavage planes in the individual mineral grains or coat the grains as thin film. This pigmentation may be due to the degradation of the iron bearing minerals.

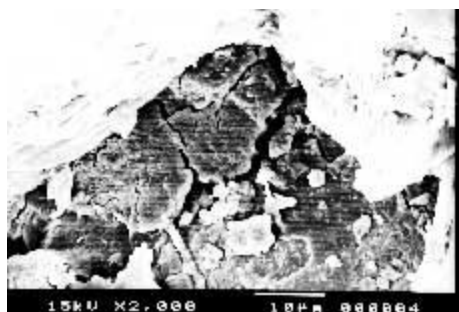
**Fig. (5):** SEM shows an intermineral network of fissures and the deformation of minerals

fissures and intramineral cracks are filled by brown iron oxyhydroxides (P15., Fig.5). plagioclase is also altered by yellowish color which is due to impregnation with iron-rich compounds.

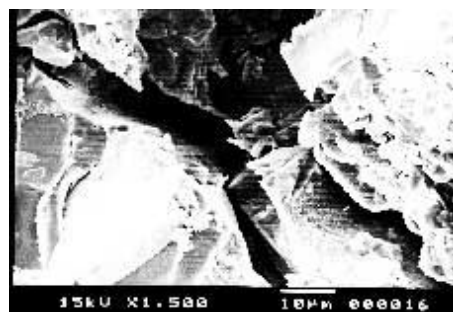
**Fig. (6):** SEM shows wide transmineral fractures cut the stones.

Mesoporosity corresponds to residual pores where distorted, opened and connected with the other system of pores and results from the development of secondary minerals that do not occupy all the available space created by weathering of the primary minerals. (Pl.5, Fig. 5) The connected pores act as channels for the soluble salts, and the movements of these salts play a great role in the deterioration of the stone. The result is powdering and flaking of the Basalt surface, in addition to carving the reliefs. It is clarified that the distribution of porous system control the different patterns of deterioration. The inhere weakness planes of the constituent minerals also affect the deterioration of the stone (Pl. 5. Fig. 6).

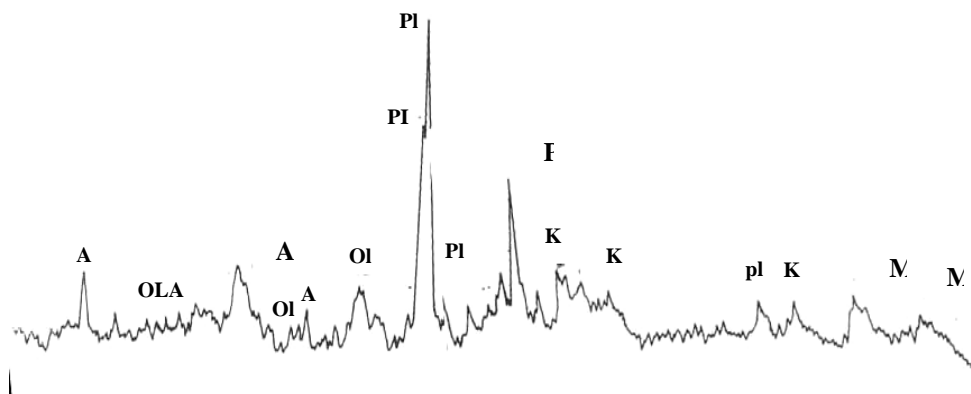
Fig. (1) : x-ray diffraction pattern of basalt shows the prescience of clay minerals

X-ray diffraction patterns of weathered basalt (Fig.1), proved that they consists of olivine, plagioclase, Anorthite. The relativitely more weathered samples are more rich in sheet silicate minerals i-e clays, chlorite. X-ray data (Fig.2) of weathered samples reveals the presence of montmorillonite and kalonilite. These swelling clay minerals causes stresses and weaken the consistency of the stone.

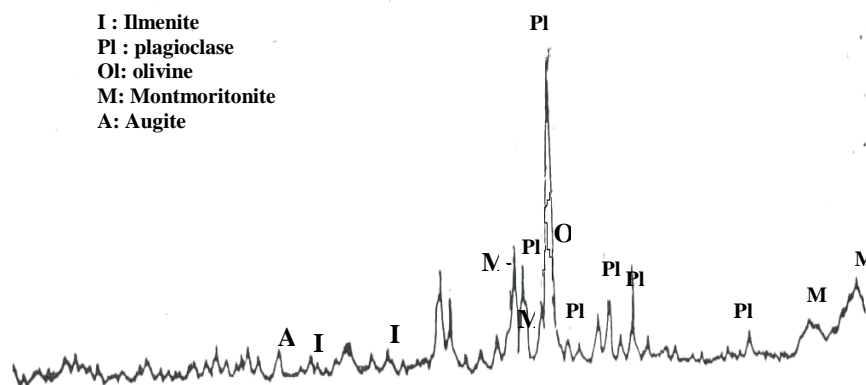
Fig. (2) : X-ray diffraction pattern of deteriorated basalt.

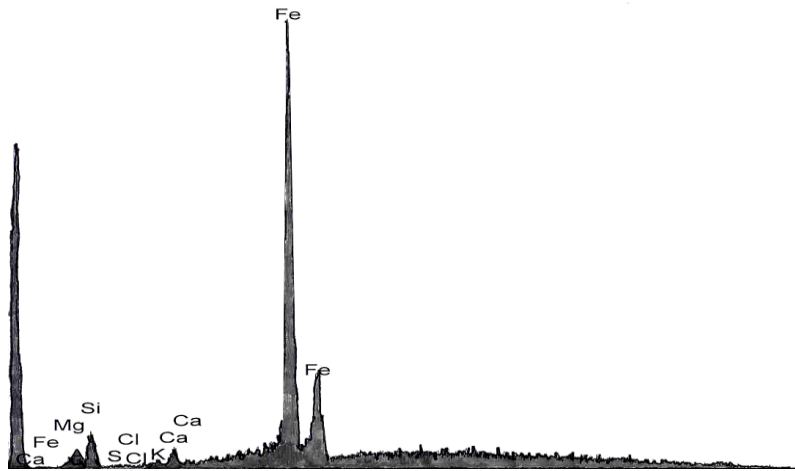
Fig. (3) : EDX shows the presence of chlorine and sulphate, in the samples.

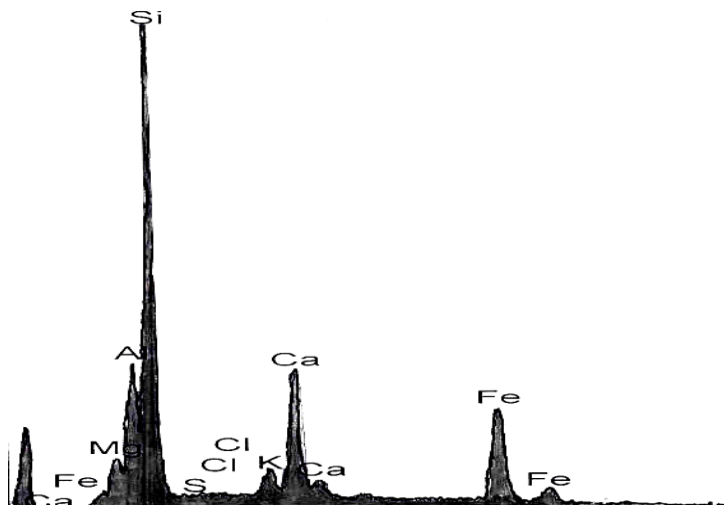
Fig. (4) : EDX shows high concentration of iron oxides and Iddingsite.

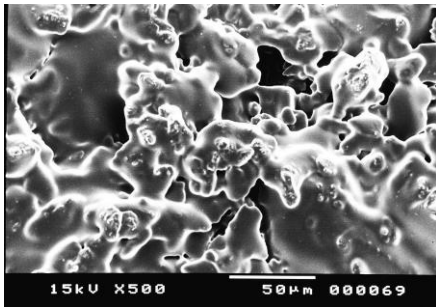
**Fig. (1): SEM micrograph shows paraloid B44 covers the grains in a dense form.**

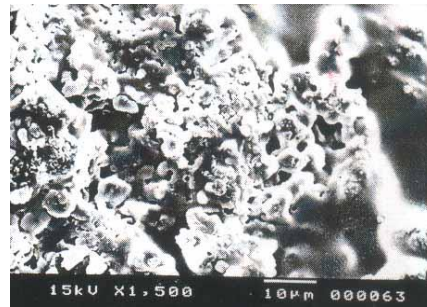
**Fig. (2) : SEM micrograph shows paraloid B44 cracked and small vugs developed after artificial weathering**

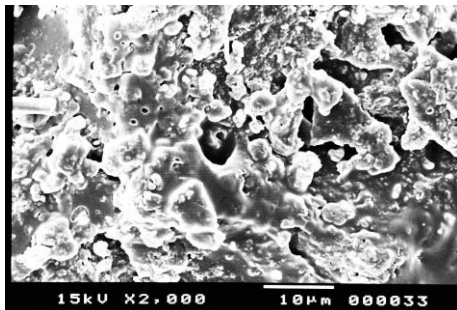
**Fig. (3): SEM micrograph shows wacker 290 formed a partial distribution between the grains.**

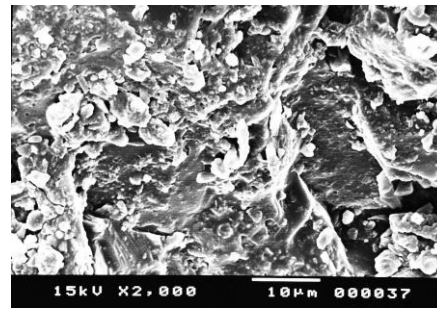
**Fig. (4): SEM micrograph shows the cracking of wacker 290 after the artificial weathering.**

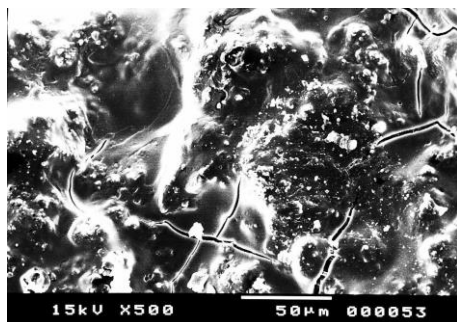
**Fig. (5) SEM micrograph shows slieaster A.R covers the grains but new cracks developed in the polymer cover.**

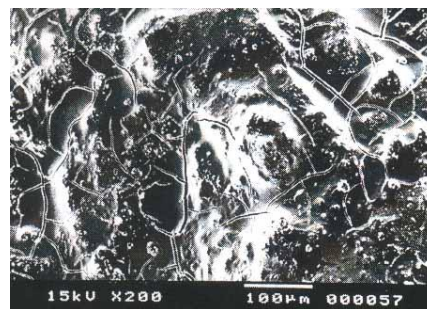
**Fig. (6): SEM micrograph shows a different cracks in slieaster A.R after artificial weathering.**

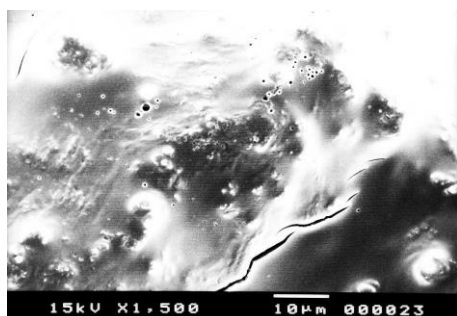
Fig. (1): SEM micrograph shows wacker OH 100 covers the stone grains in a dense form.

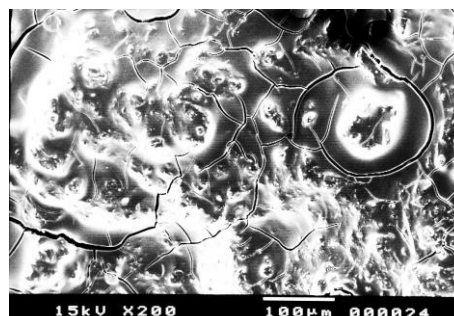
Fig. (2) : SEM micrograph shows the polymer Shrinkage and spall off after exposure to crack weathering.

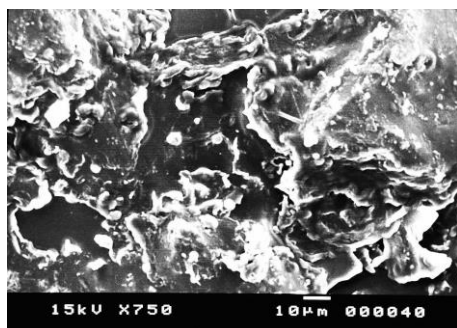
Fig. (3): SEM micrograph shows Tegovakon V forms a partially film which coats the stone grains.

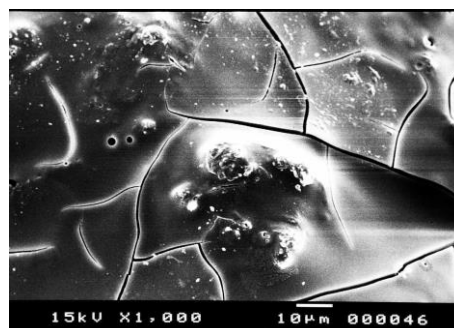
Fig. (4): SEM micrograph shows Tegovakon V shrinkage and cracked after artificial weathering.

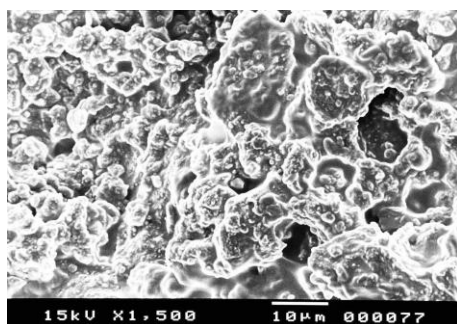
Fig. (5): SEM micrograph shows Rhodorsil 224 partially forms a thick cover distributed between the grains.

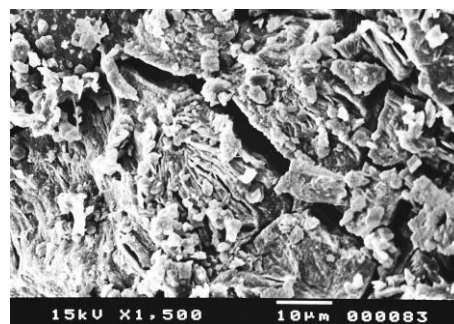
Fig. (6): SEM micrograph shows Rhodorsil 224 cracked and spall of after artificial weathering.
